Stacking Power MOSFETs

PMOS Configuration

By Kendrick De La Pena

Updated: 08/07/2014

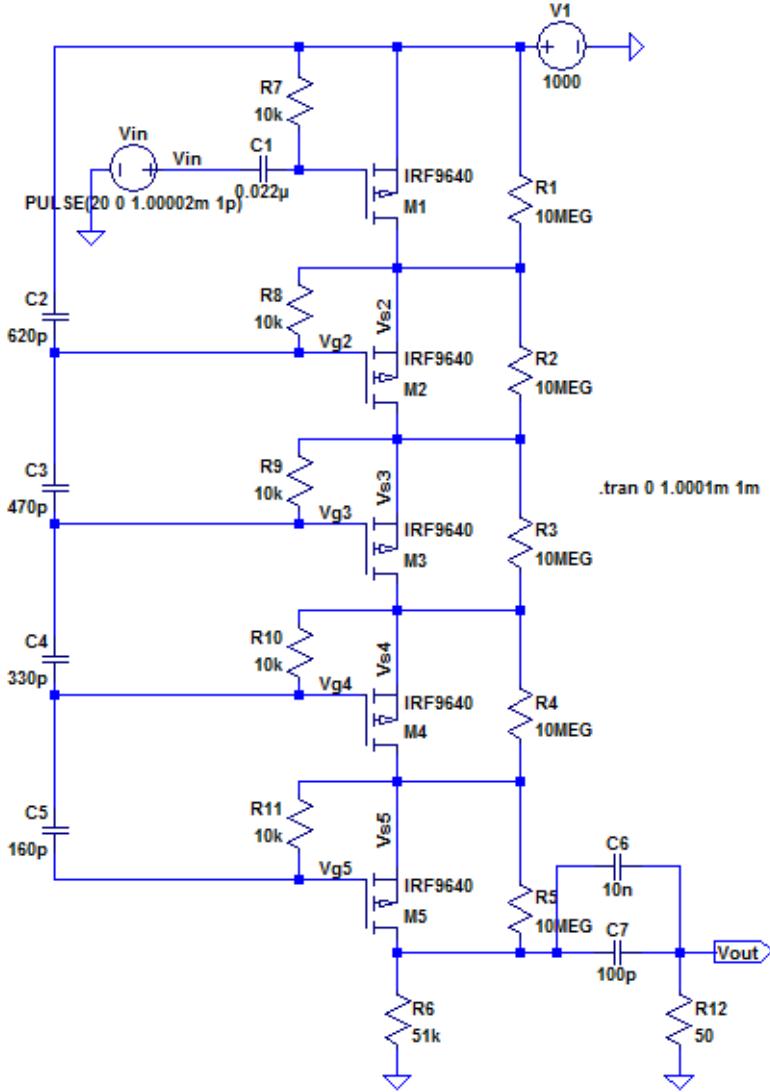
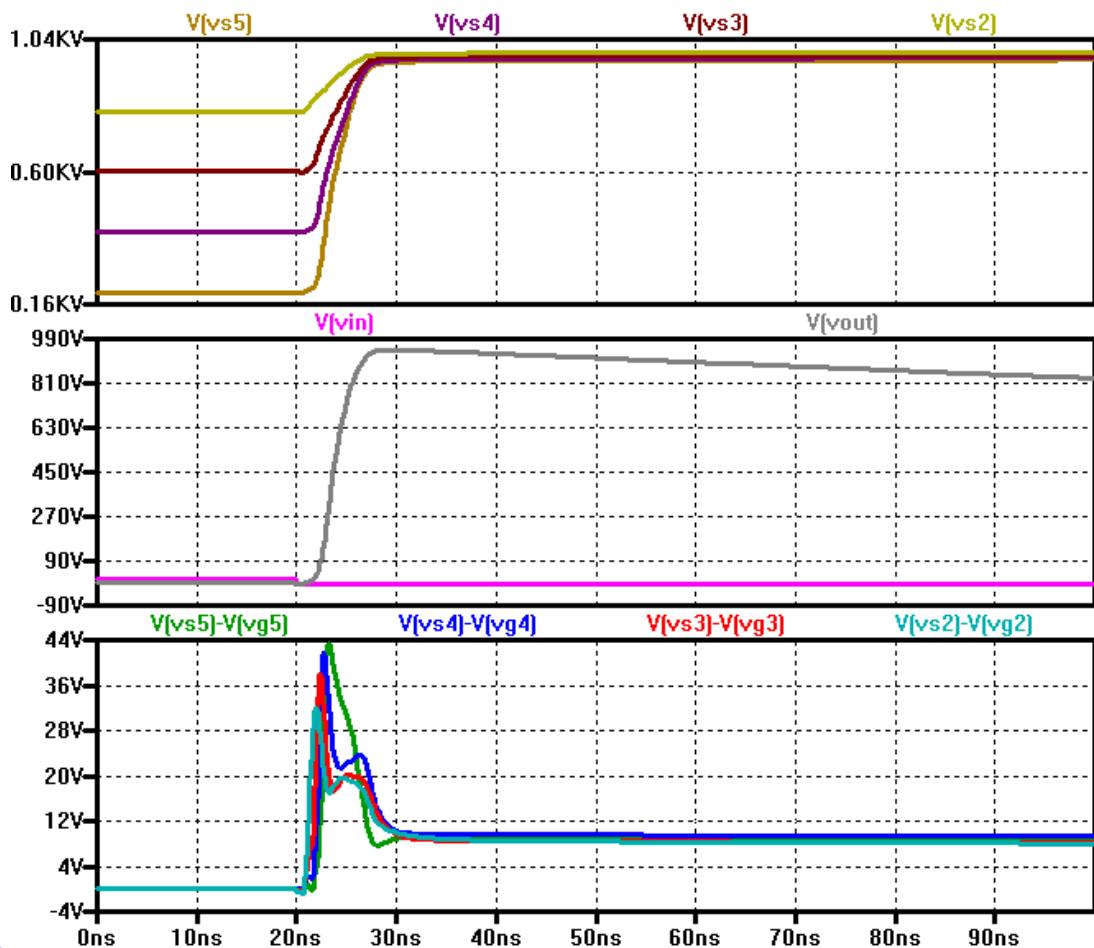
Test 1a – Simulation & Values

*Values reflect parts available

- PMOS Configuration; 5 Stack PMOS
- MOSFET:
 - IFR9640, $V_{DS} = -200$ V, $R_{DS(on)} = 0.5$ Ohms
- Capacitance Values:
 - 150 pF, 300 pF, 450 pF, 600 pF
- Max Voltage:
 - 1000 V

*To ensure the MOSFETs turn on, increase C_2 to **150 pF**

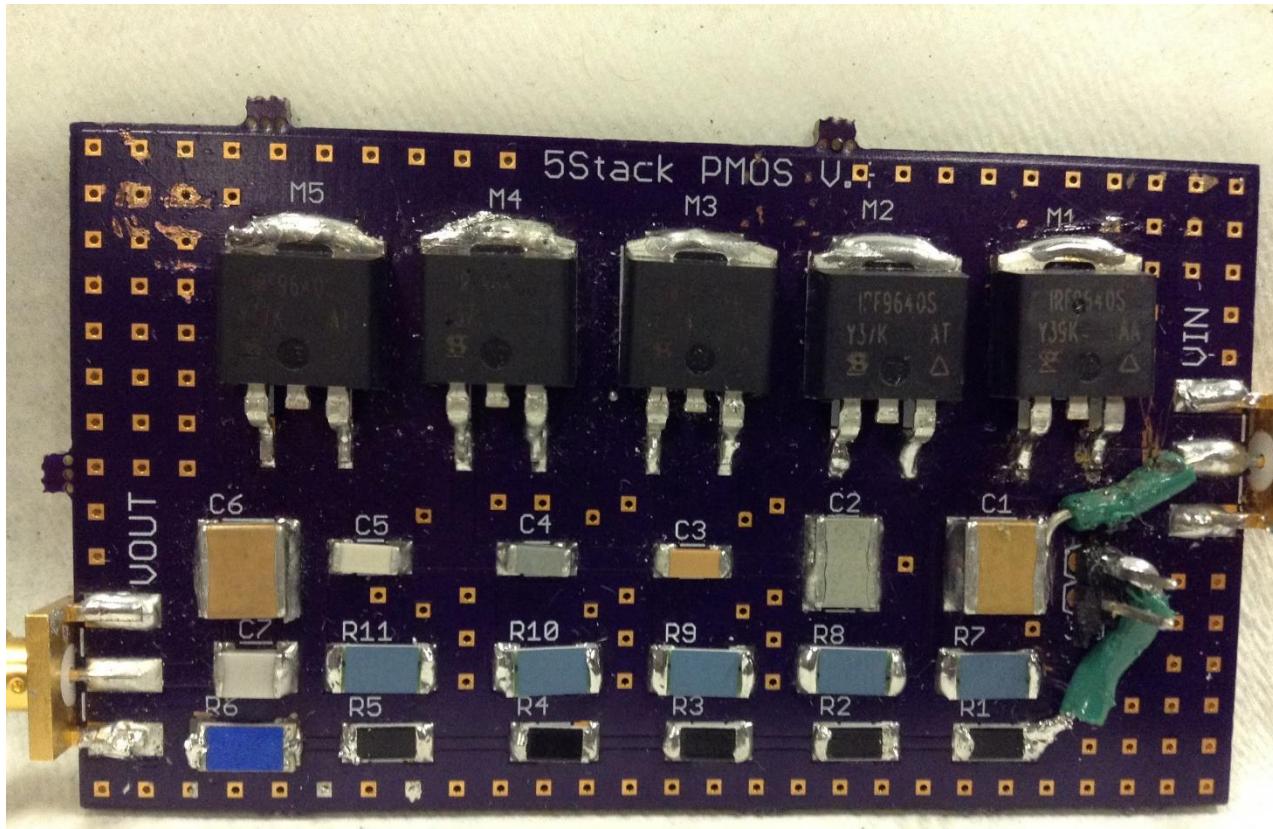
Test 1a – Chip

* The VIN and HV were switched in the PCB and needed to be rewired

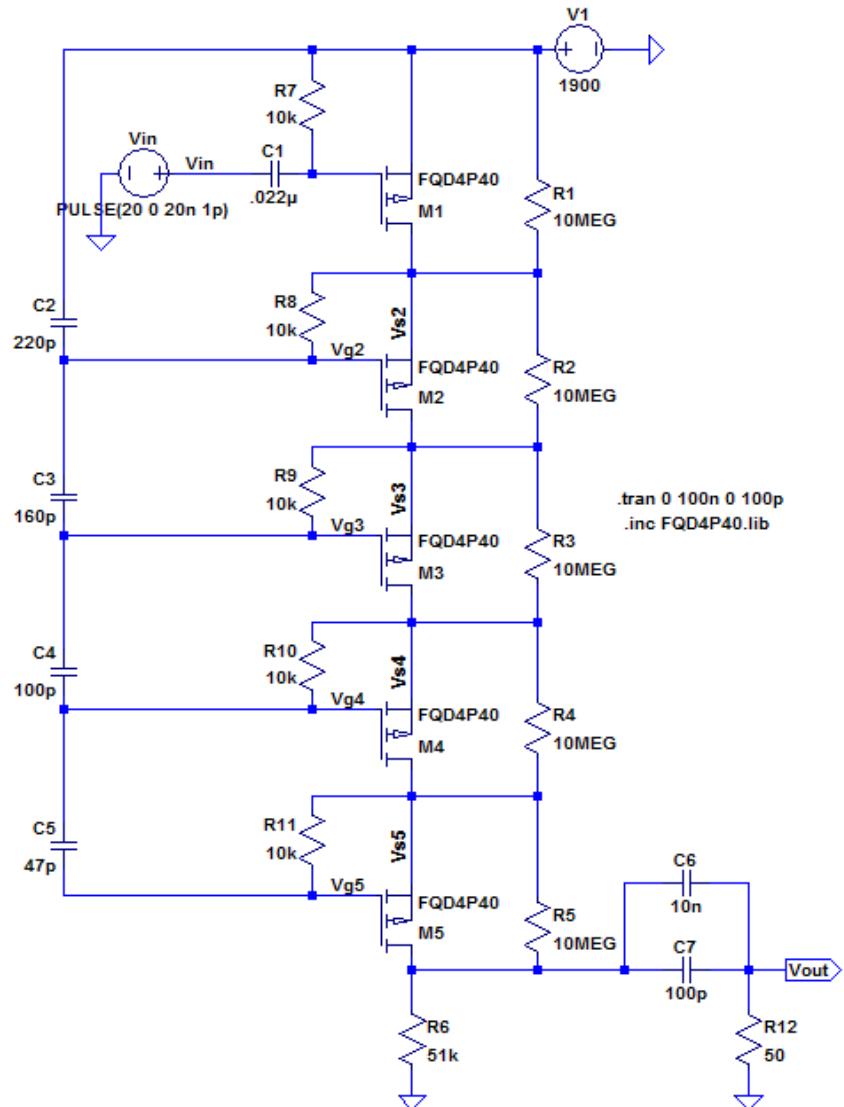
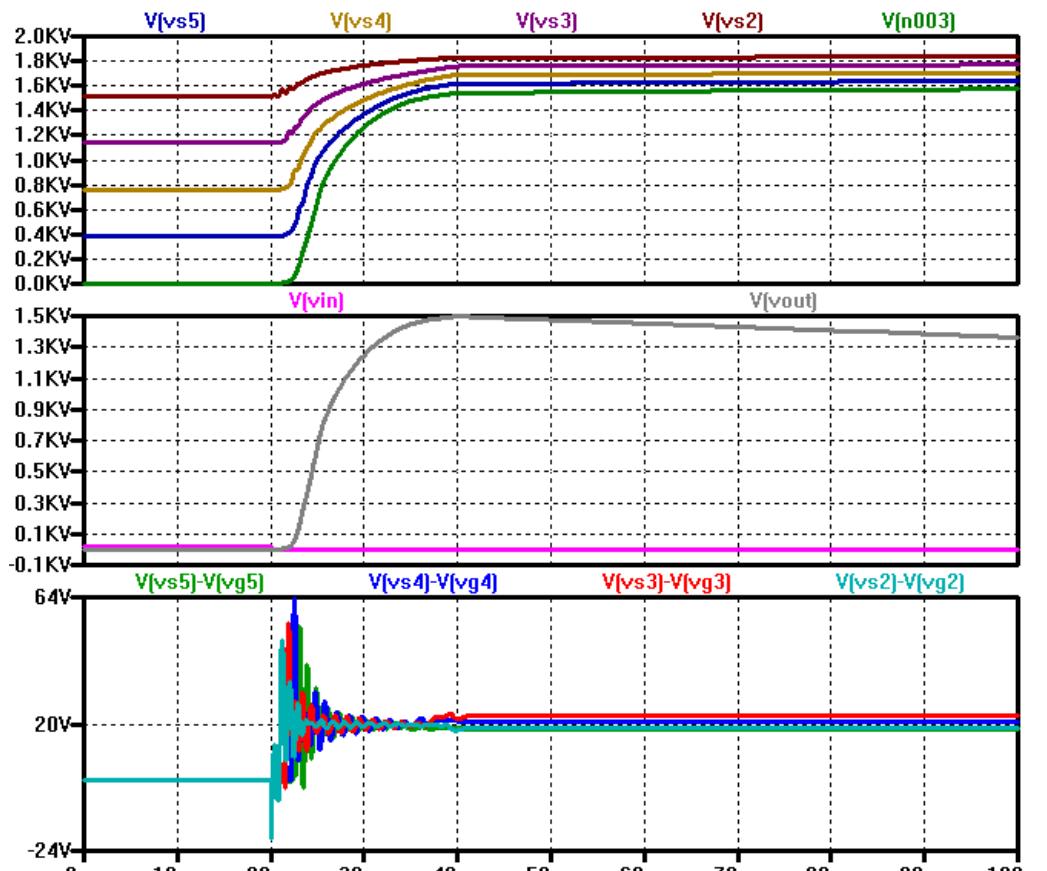
Test 1b – Simulation & Values

*Values reflect parts available

- PMOS Configuration; 5 Stack PMOS
- MOSFET:
 - FQD4P40, $V_{DS} = -400$ V, $R_{DS(on)} = 3.1$ Ohms
- Calculated Capacitance Values:
 - 50 pF, 100 pF, 150 pF, 200 pF
- Max Voltage:
 - 2000 V

*To ensure the MOSFETs turn on, increase C_2 to 50 pF

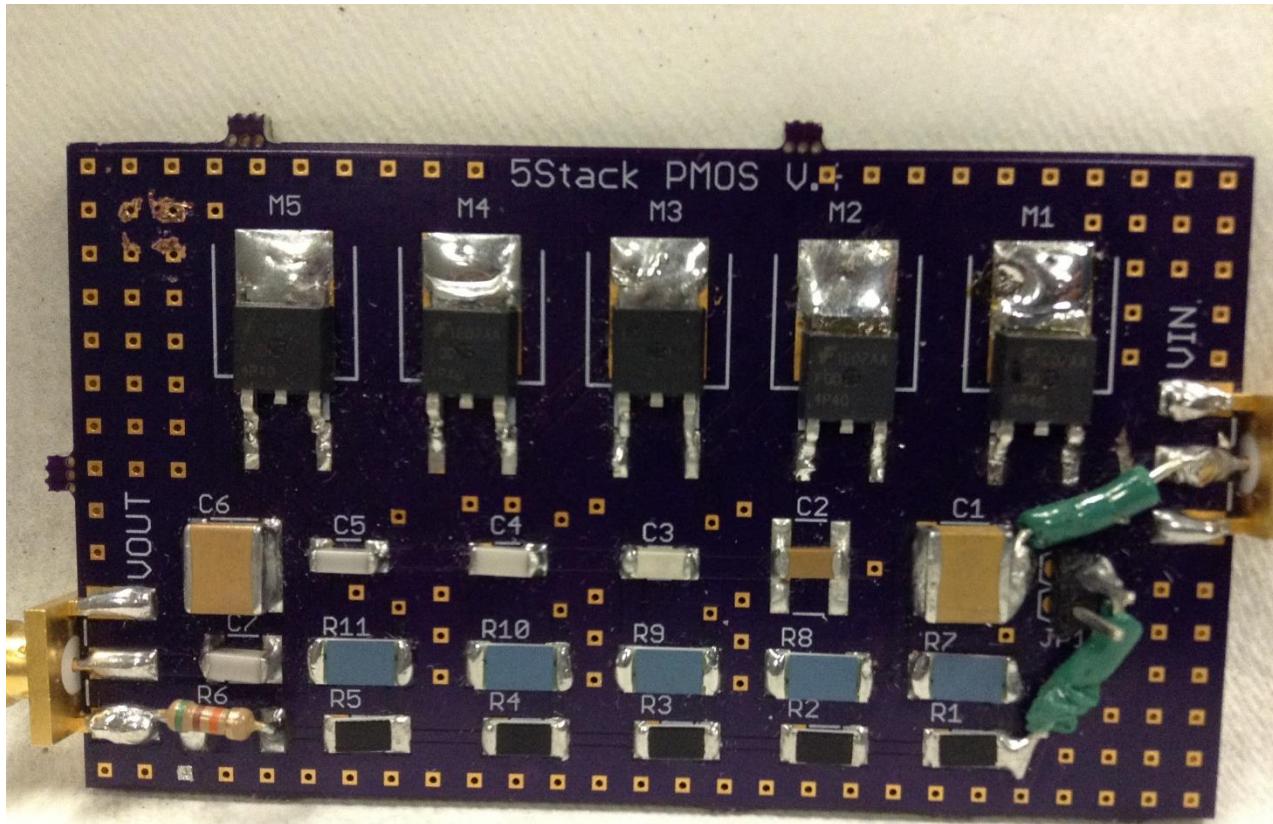
Test 1b – Chip

* The VIN and HV were switched in the PCB and needed to be rewired
